CHARACTERIZATION OF "WHITE LAYER" AND CHROME PLATING  
ON FIRED CANNON AND ON LABORATORY SIMULATION SAMPLES

R. M. Fisher and A. Szirmae  
U. S. Steel Corp., Research Laboratory  
Monroeville, Pa. 15146

June 1982

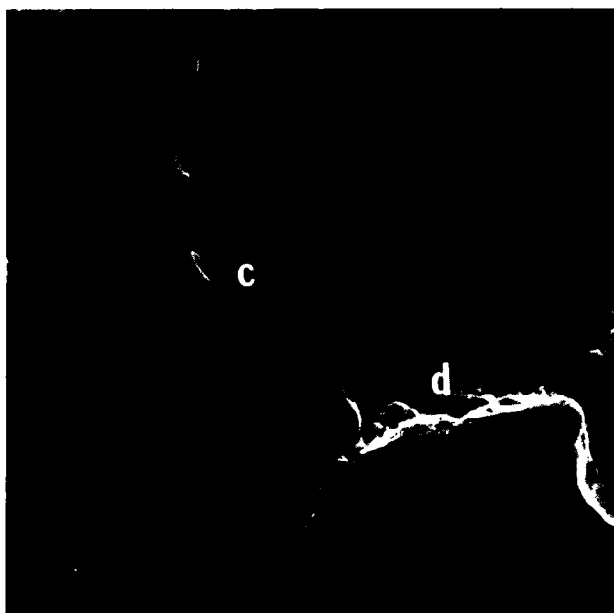
Figure 5

Scanning electron micrographs and X-ray spectra of material in cracks near to the surface.

Scanning electron micrographs, taken at a point in the sample where the depth of grind was even greater, are illustrated in Figure 5. Both regions show a very high level of aluminum and copper, and region (d) reveals the presence of a considerable amount of sulfur as well. The next series of micrographs shown in Figure 6 are even further along the taper section where the depth of grind is considerable; even here, perhaps 200 microns below the surface, the aluminum and copper levels are surprisingly high in the crack. These elements were found right up to the tip of the crack, as illustrated in the micrographs and X-ray

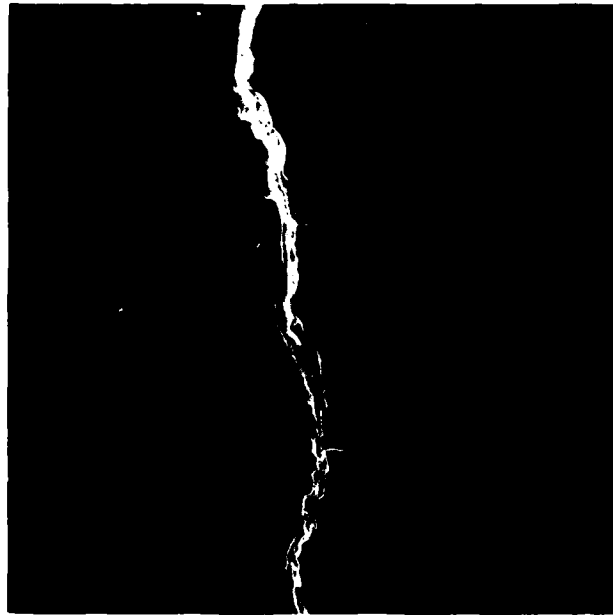
Figure 6

Scanning micrographs and X-ray spectra of material in cracks about 200  $\mu\text{m}$  below the surface.

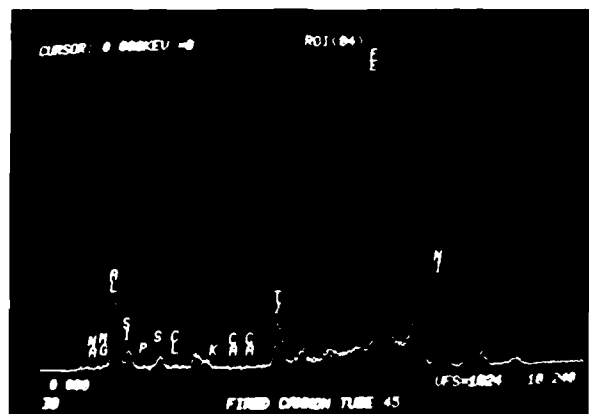
Figure 8

Scanning micrographs of a 16° taper section of a Ni-plated sample of cannon tube (T-45). Al and Cu are detected well into the crack along with evidence of penetration of Ni during plating.

Scanning electron micrographs of a  $16^\circ$  taper cross section of a nickel-plated sample of cannon tube T-45 are shown in Figure 8. Again, it may be noted that aluminum, titanium and copper are present in the cracks, along with some nickel that apparently penetrated during the plating process. Note the dual crack structure comprising a series of very shallow closely spaced cracks shown in the left of micrograph 8b, and a network of cracks with much larger spacing in the central area. Optical and scanning electron micrographs of the etched  $16^\circ$  taper cross section of cannon tube (T-45) are shown in Figure 9. These micrographs illustrate the essential features that result from white-layer formation. Starting at the top (in the steel matrix) and proceeding toward the surface, the first region is the "altered ferrite" region, which is the heat-affected zone where the steel is cycled through the austenite-martensite transformation. Because of the high alloy content, this steel has considerable hardenability and the slow cooling rate due to the self-quenching in the steel tube is still sufficient for some martensite to form. The lighter etched area is altered austenite, which contains a large amount of substructure. Finally, the lower optical micrograph in Figure 9b shows an outer thin white rim over the surface.

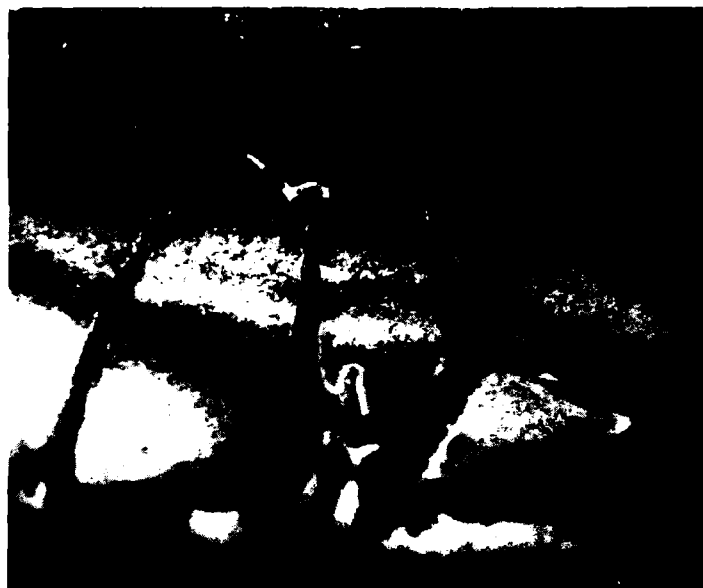
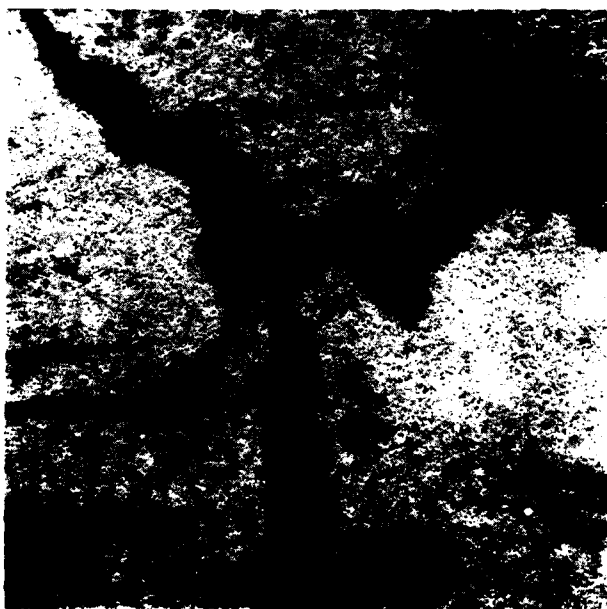
Optical and scanning micrographs of etched 16° taper cross section of cannon tube (T-45).

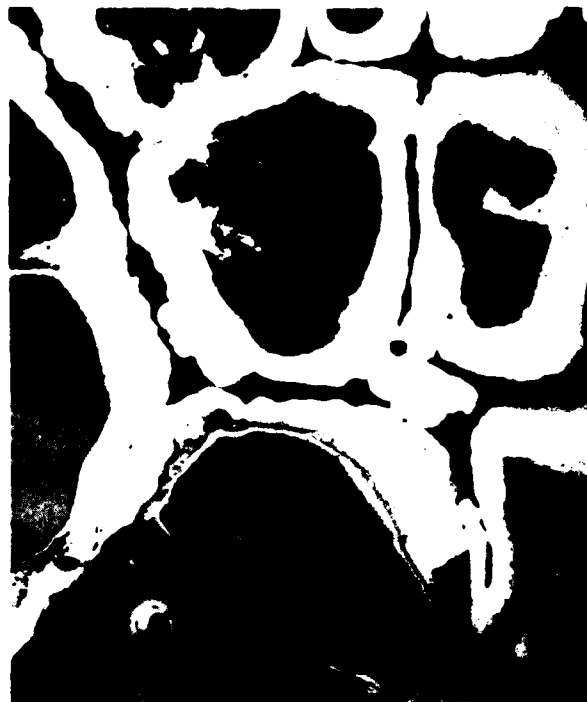
Figure 12

Optical and scanning electron micrographs of 3° Ni-plated cross section of T-45. White areas are nickel plating. Areas marked in (c) were analyzed for carbon by Auger spectroscopy.

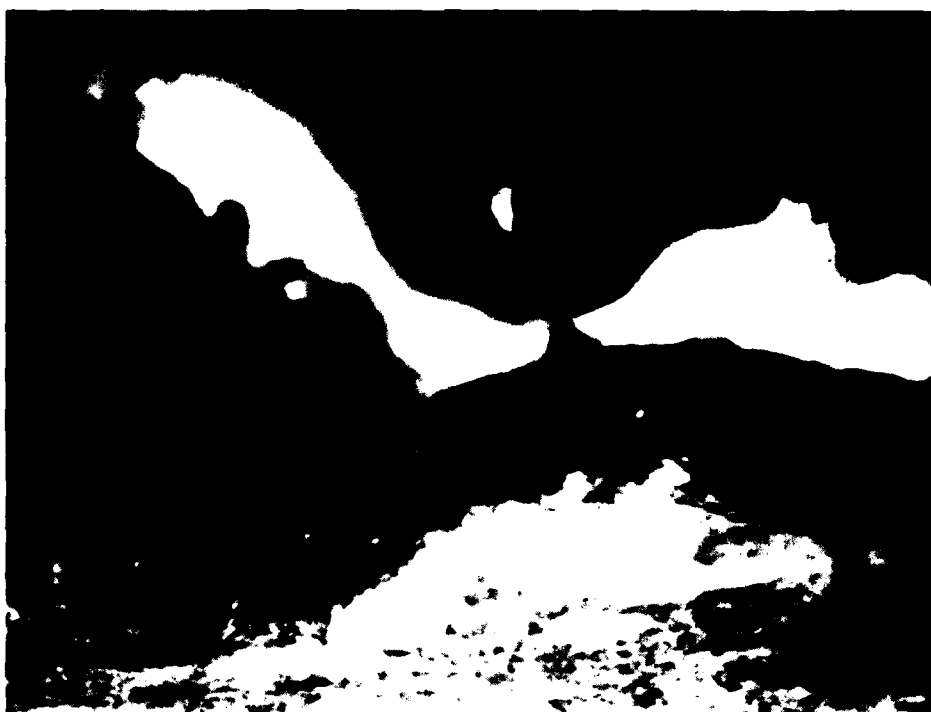
Figure 21

Transmission electron micrographs of carbide-austenite interface.

locations is illustrated in Figure 21c. The austenite also exhibits several as yet uninterpreted microstructural features. The micrograph in Figure 21b shows a group of lenticular areas containing fine striations which are reminiscent of but not identical to martensite plates. Other austenite areas, shown in the lower halves of Figures 21a and 22a, also exhibit very fine striations. In both cases these structures may result from precipitation of fine carbides on faults resulting from plastic deformation during rapid cooling. High resolution electron microscopy will be required to identify the specific nature of this structure, which is presumably responsible for the high hardness. The martensitic structure in the altered ferrite region is illustrated in Figure 22b.

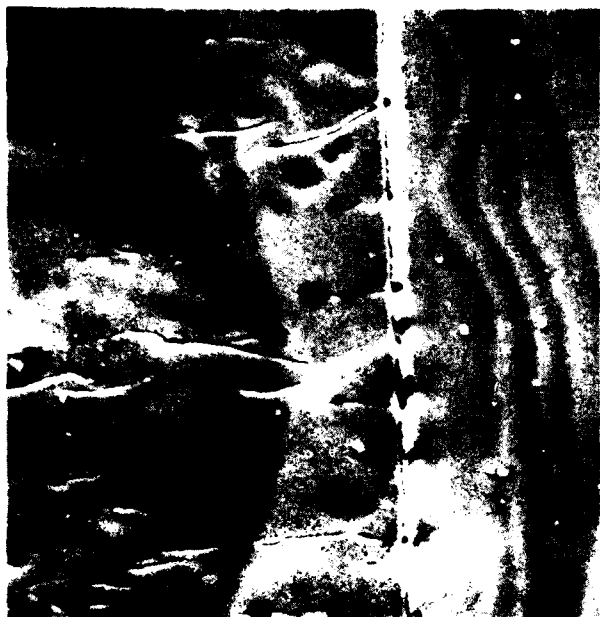
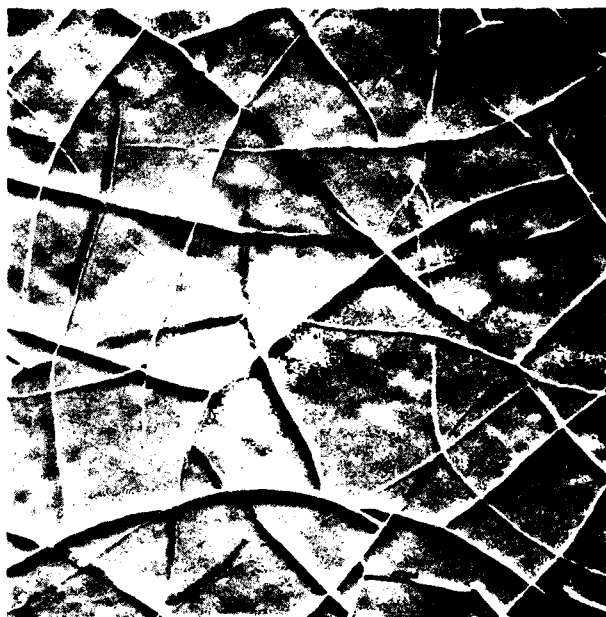
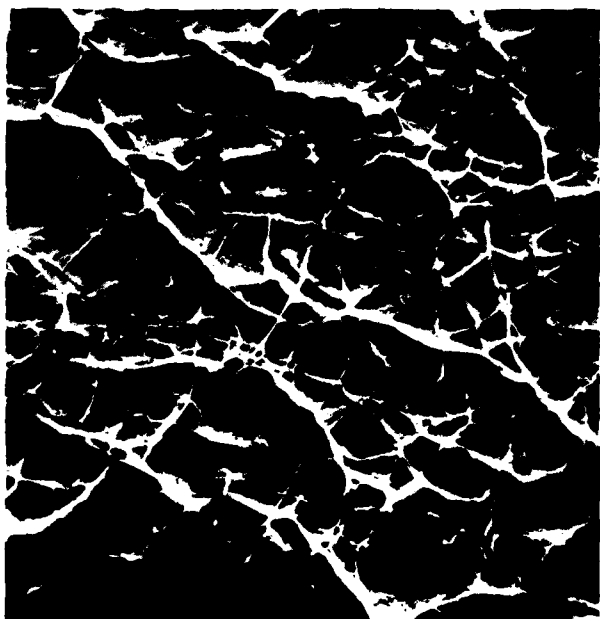
Figure 1

Optical micrographs of chromium electrodeposited at 55°C showing Knoop hardness values on cross section (a), and microcracks revealed by electropolishing cross section (b), and surface section (c).

Optical micrographs of cross and surface sections of sample A of bright hard chromium are shown in Figure 1. No microcracks are visible on the mechanically polished surface. However, electrolytic polishing-etching does reveal the presence of numerous cracks perpendicular to the plated surface, as shown in Figure 1b, and on the planar section shown in Figure 1c. At higher magnification in the scanning electron microscope, cracks were revealed very clearly in both cross and parallel sections of the chrome plate, as shown in Figure 2. The appearance of the cracks suggested that they contain some unknown material, although this effect was not fully reproducible between the usual alternate polishing and etching cycles.

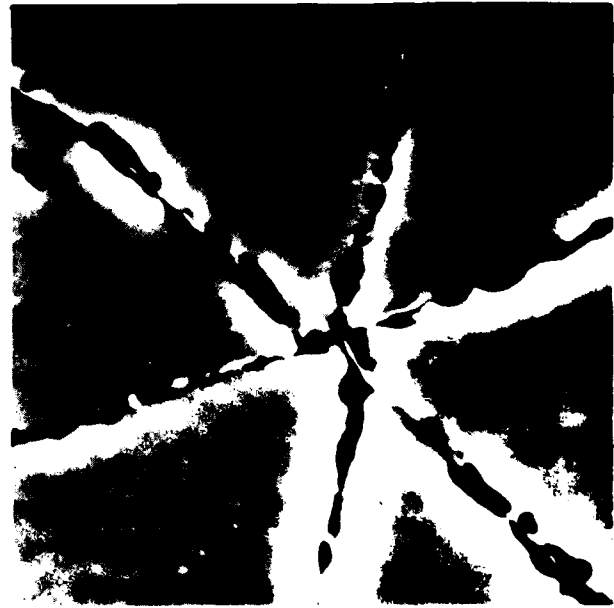
Figure 6

Scanning electron micrographs of chromium electrodeposited at 55°C and then annealed at 900°C for 1 hr to enlarge microcracks; both cross sections (a), (b), and surface sections (c), (d) were electropolished.

The crack pattern in the electroplated chromium becomes more pronounced after heating for 1 hour at  $900^\circ\text{C}$ , and air cooling. Examples of cross and parallel sections are shown in Figure 6. It does not appear that the cracks are any more numerous than before but have become wider, presumably because of further contraction during annealing of the electrodeposit. The hardness

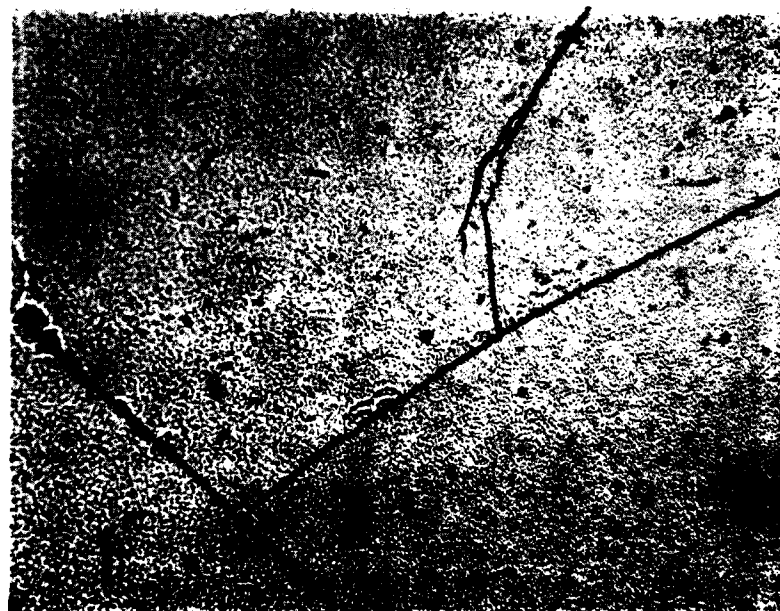
Figure 8

Optical micrographs of chromium electrodeposited at 85°C showing Knoop hardness values (a), and coarse microcracks in cross section (b), and surface section (c).

Sample B, (chromium electrodeposited at  $85^{\circ}\text{C}$ ) was examined in the manner described in the preceding section of this report. Optical micrographs of the cross and surface sections are shown in Figure 8, and scanning electron micrographs in Figure 9. It may be noted that the hardness of 650 KHN is about half that of sample A and the crack spacing is about 10X coarser. High-voltage electron microscopy of ion-thinned sections of the  $85^{\circ}\text{C}$  sample revealed a much coarser grain size and more random grain orientations, as illustrated in Figure 10.

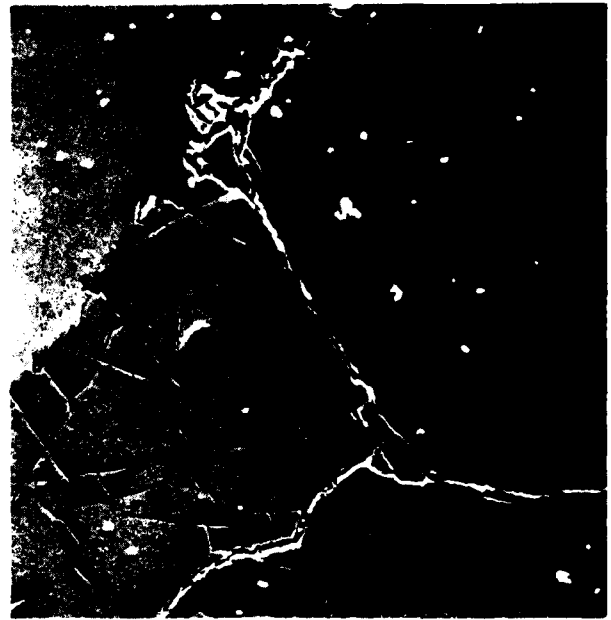
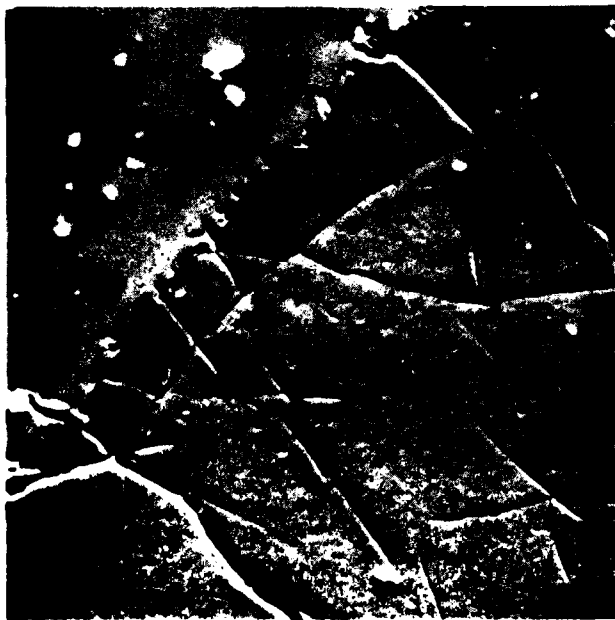
Scanning electron micrographs of mechanically polished  
cross section of chromium electroplate on a fired cannon.

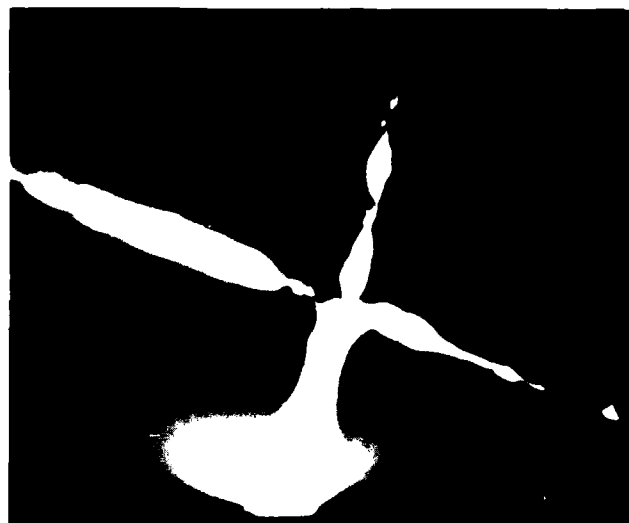
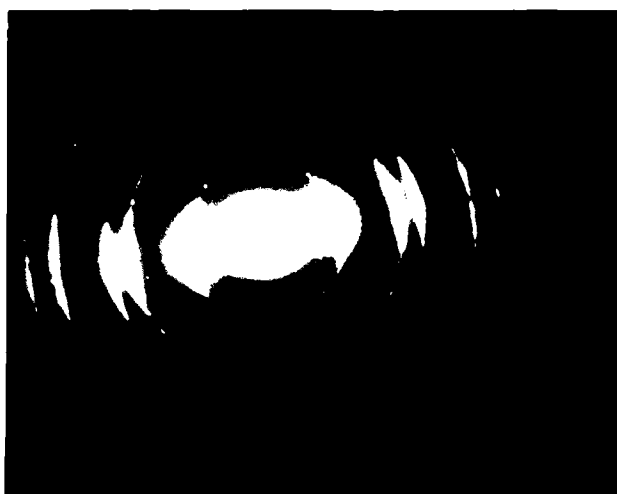
Figure 14

Scanning electron micrographs of electropolished surface  
of chromium on a fired cannon.

14 after electropolishing. The grain, dislocation, and crack structures in thin foils are illustrated in the high-voltage micrographs in Figure 15. The cracks are wider and more complex after firing as compared with annealing at 870 to 900°C for laboratory samples. During firing the surface is heated to >1100°C for a few milliseconds and is also exposed to explosive pressures. More detailed study of the crack structures should be carried out.
